# Inspection Report

1234 Main St  
Anytown OR 99999

**Thompson Home Inspection, LLC**

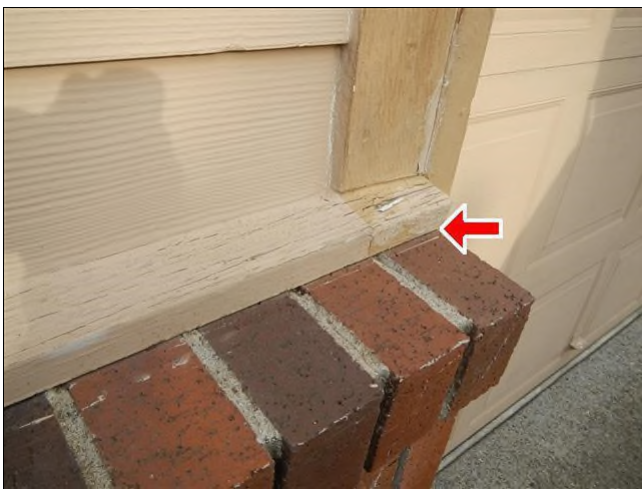
Item 1(Picture) Paint needed on exterior of house to prevent water damage.

Paint needed on exterior of house to prevent water damage.

Paint touch-ups needed. Some areas of the siding or trim need to have prep work (scraping, sanding, caulking, and priming as needed) and paint touch-ups. I recommend these areas be repaired by a qualified contractor as weather permits.

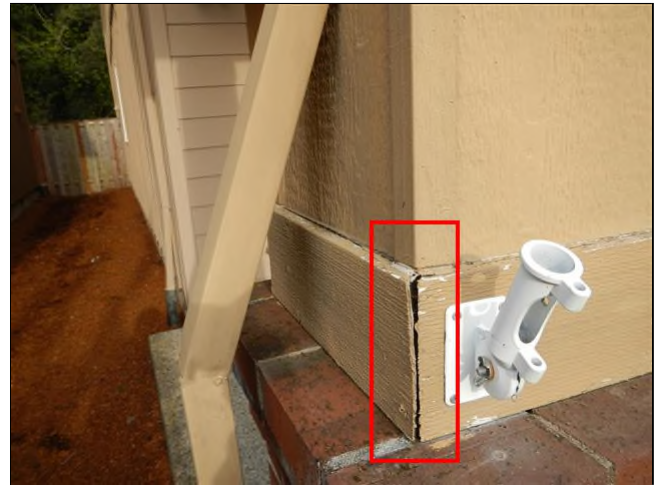
Item 2(Picture) Cracks around trim or siding butt joints or wall penetrations should be sealed with caulking. This is an ongoing maintenance job for nearly all homes.

Cracks around trim or siding butt joints or wall penetrations should be sealed with caulking.

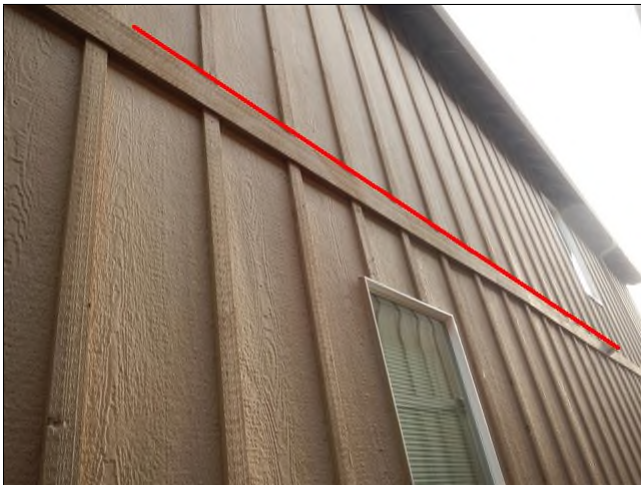
Item 3(Picture) When repainting make sure to reapply caulking to prevent water from getting held up on top edge and getting in between board and siding, creating water damage.

When repainting make sure to reapply caulking to prevent water from getting held up on top edge and getting in between board and creating water damage.

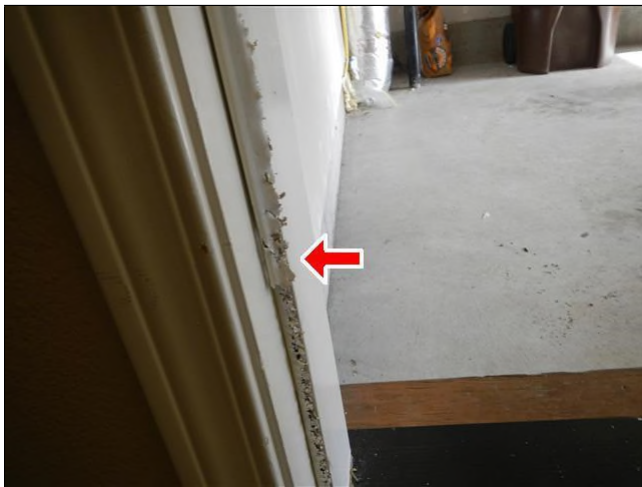
Item 1(Picture) Weather strip, on garage door needs repair.

Weather strip, on garage door needs repair.

Repair is recommended.

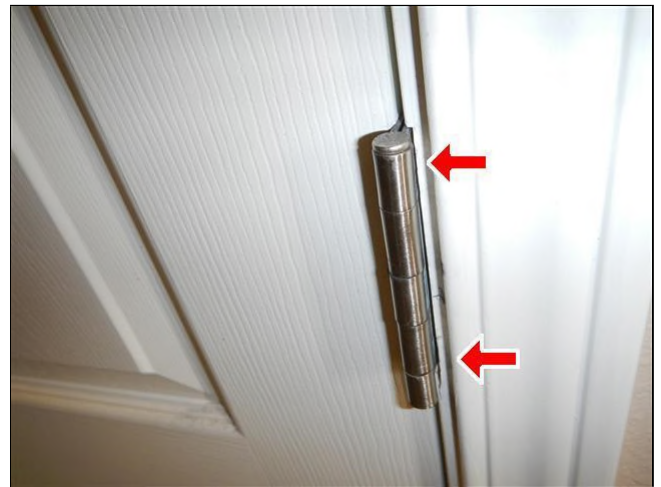
Item 2(Picture) Bottom hinge needs repair. Screw is loose and needs a longer bigger screw in place.

Bottom hinge needs repair. Screw is loose and needs a longer bigger screw in place.

Weather strip, on garage door needs repair. Bottom hinge needs to be secured better to jamb. Recommend longer screws to pull it to door. Some screws were stripped and, as a result, are causing the door to not have a weather tight seal when closed.

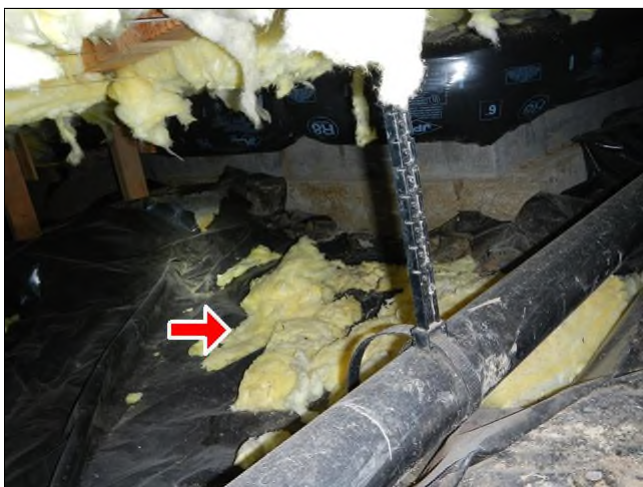
Item 1(Picture) Some insulation has fallen, needs to be removed in order to prevent habitable locations for pests.

Some insulation has fallen, needs to be removed in order to prevent habitable locations for pests.

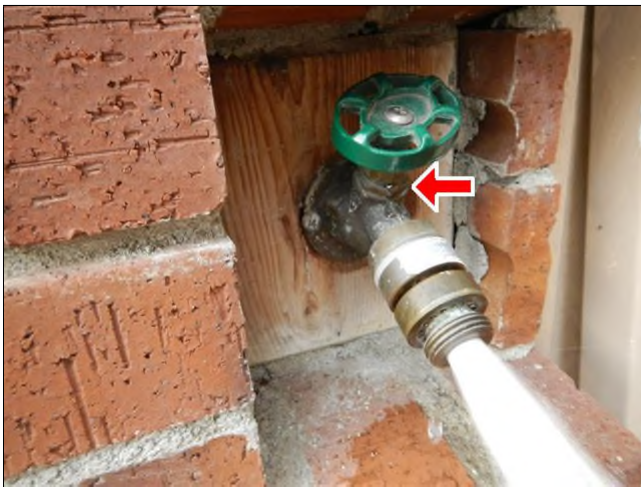
Item 1(Picture) Both outside hose bibs leak at the stem, when turned on, and need to be repaired. This is usually an easy fix and can be repaired by replacing the internal string in the faucet.

Both outside hose bibs leak at the stem, when turned on, and need to be repaired. This is usually an easy fix and can be repaired by replacing the internal string in the faucet.

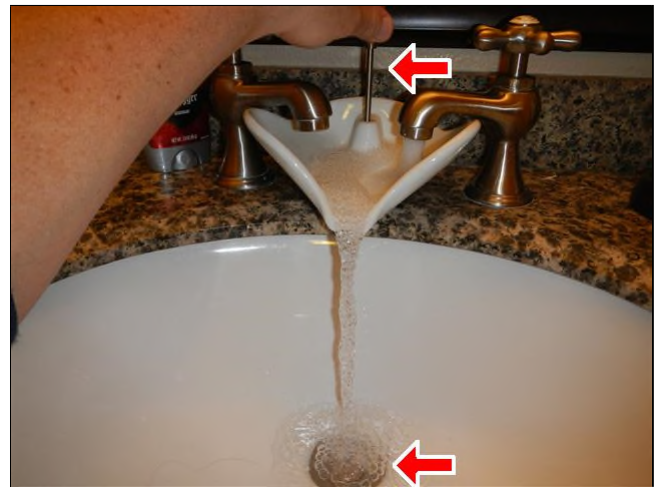
Item 2(Picture) One pop up stopper is in need of repair. Upstairs bathroom in hallway.

One pop up stopper is in need of repair. Upstairs bathroom in hallway.

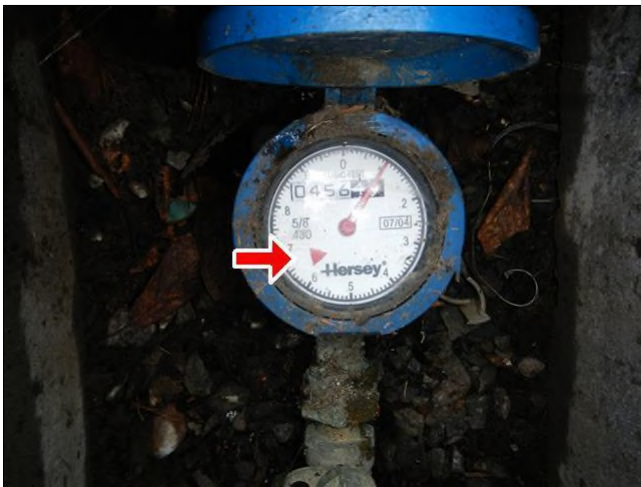
Picture 3 The water meter was checked for movement while everything in the house was turned off. There was none. This means there were no major leaks in the system, however, slow drips are not detected by this means.

The water meter was checked for movement while everything in the house was turned off. There was none. This means there were no major leaks in the system, however, slow drips are not detected by this means.

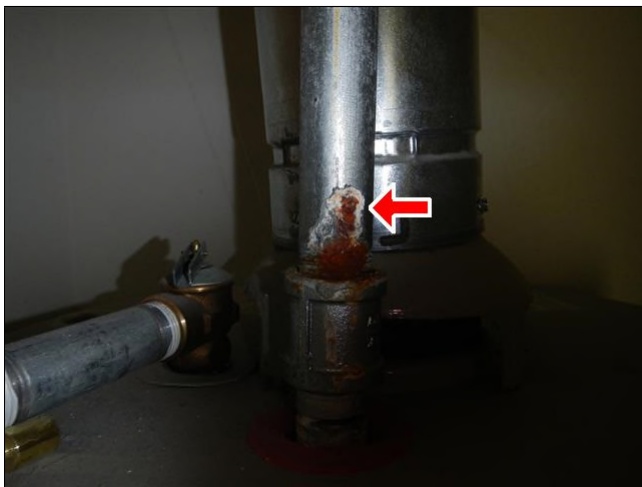
Item 1(Picture) Small pin hole leak needs repair.

Small pin hole leak needs repair.

Evaluation and repair by a licensed plumbing contractor is recommended.

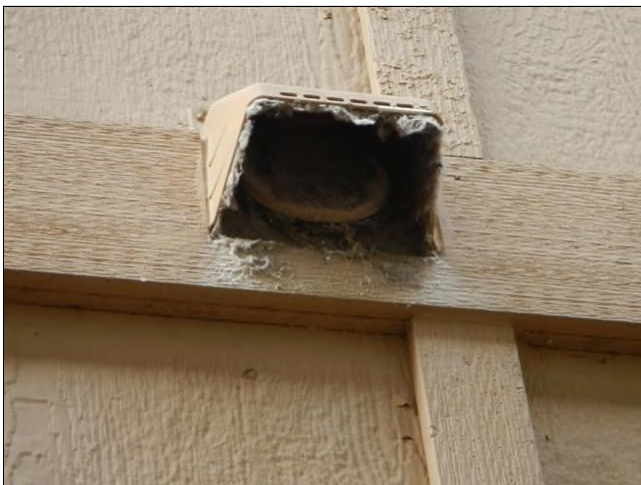
Item 1(Picture) The dryer vent needs to be cleaned of lint. As a result, the flap is not closing properly and is a potential pest entrance to the home. Repair is recommended.

The dryer vent needs to be cleaned of lint. As a result, the flap is not closing properly and is a potential pest entrance to the home. Repair is recommended.

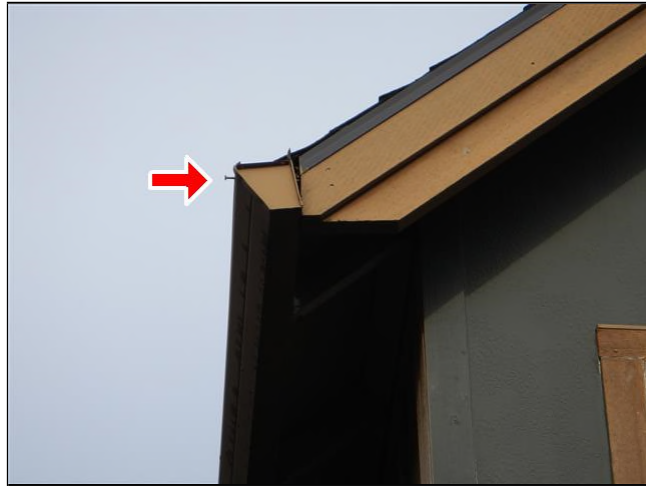
The gutter spikes need to be tightened to keep the gutters tight against the roof.

Item 1(Picture) Spike protruding out needs to be tightened in order to keep gutter against fascia and water away from house.

Spike protruding out needs to be tightened in order to keep gutter against fascia and water away from house.

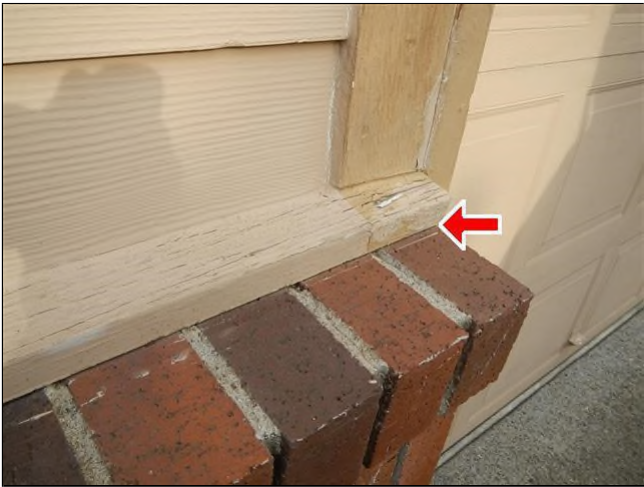
Item 1(Picture) Paint needed on exterior of house to prevent water damage.

Paint needed on exterior of house to prevent water damage.

Paint touch-ups needed. Some areas of the siding or trim need to have prep work (scraping, sanding, caulking, and priming as needed) and paint touch-ups. I recommend these areas be repaired by a qualified contractor as weather permits.

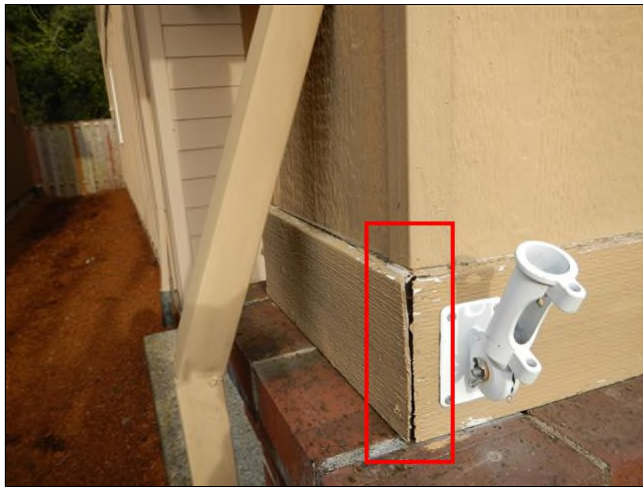
Item 2(Picture) Cracks around trim or siding butt joints or wall penetrations should be sealed with caulking. This is an ongoing maintenance job for nearly all homes.

Cracks around trim or siding butt joints or wall penetrations should be sealed with caulking.

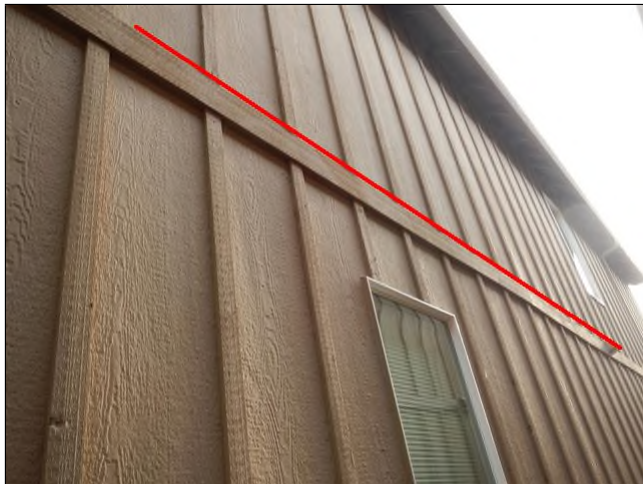
Item 3(Picture) When repainting make sure to reapply caulking to prevent water from getting held up on top edge and getting in between board and siding, creating water damage.

When repainting make sure to reapply caulking to prevent water from getting held up on top edge and getting in between board and creating water damage.

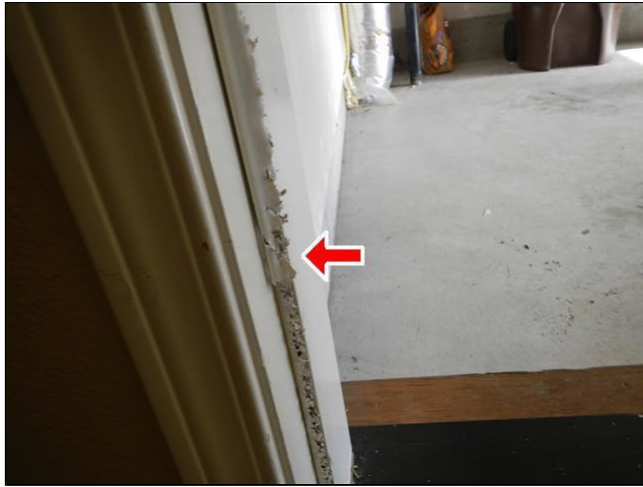
Item 1(Picture) Weather strip, on garage door needs repair.

Weather strip, on garage door needs repair.

Repair is recommended.

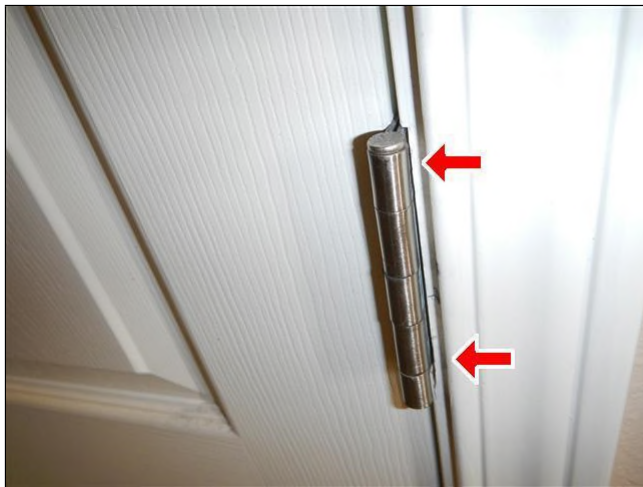
Item 2(Picture) Bottom hinge needs repair. Screw is loose and needs a longer bigger screw in place.

Bottom hinge needs repair. Screw is loose and needs a longer bigger screw in place.

Weather strip, on garage door needs repair. Bottom hinge needs to be secured better to jamb. Recommend longer screws to pull it to door. Some screws were stripped and, as a result, are causing the door to not have a weather tight seal when closed.

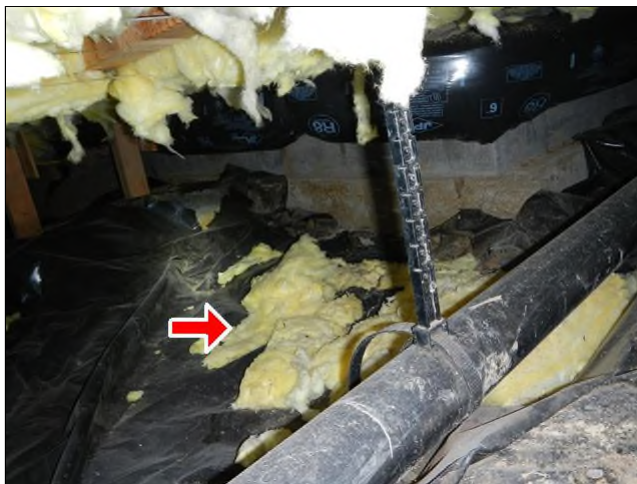
Item 1(Picture) Some insulation has fallen, needs to be removed in order to prevent habitable locations for pests.

Some insulation has fallen, needs to be removed in order to prevent habitable locations for pests.

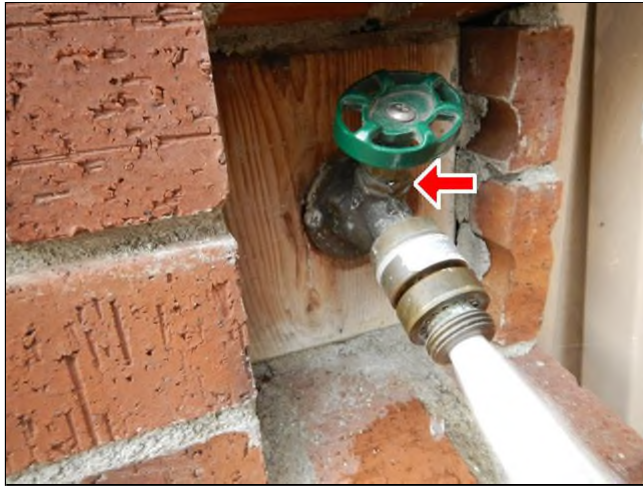
Item 1(Picture) Both outside hose bibs leak at the stem, when turned on, and need to be repaired. This is usually an easy fix and can be repaired by replacing the internal string in the faucet.

Both outside hose bibs leak at the stem, when turned on, and need to be repaired. This is usually an easy fix and can be repaired by replacing the internal string in the faucet.

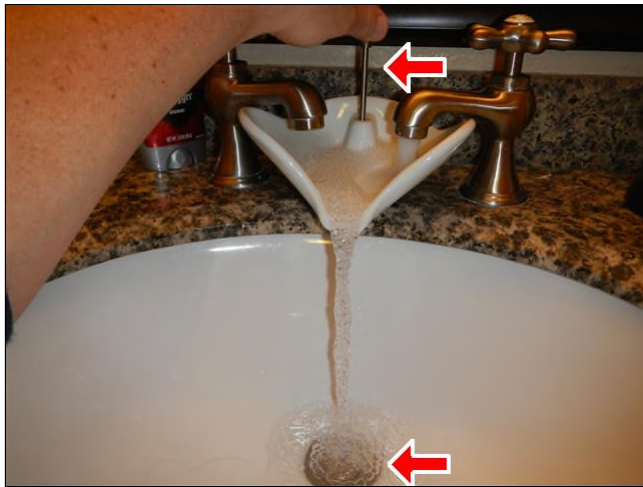
Item 2(Picture) One pop up stopper is in need of repair. Upstair bathroom in hallway.

One pop up stopper is in need of repair. Upstairs bathroom in hallway.

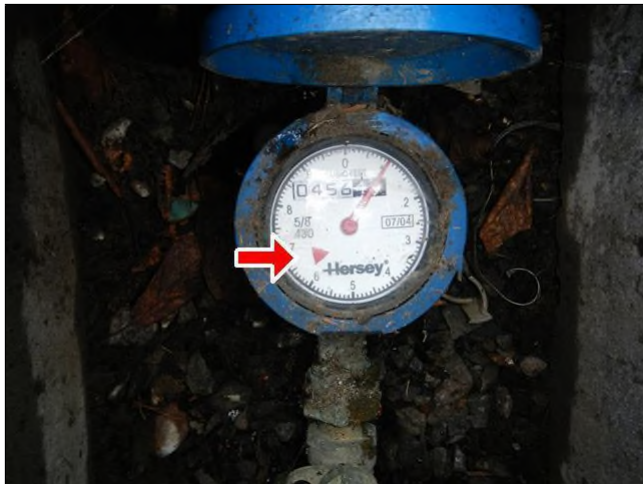
Picture 3 The water meter was checked for movement while everything in the house was turned off. There was none. This means there were no major leaks in the system, however, slow drips are not detected by this means.

The water meter was checked for movement while everything in the house was turned off. There was none. This means there were no major leaks in the system, however, slow drips are not detected by this means.

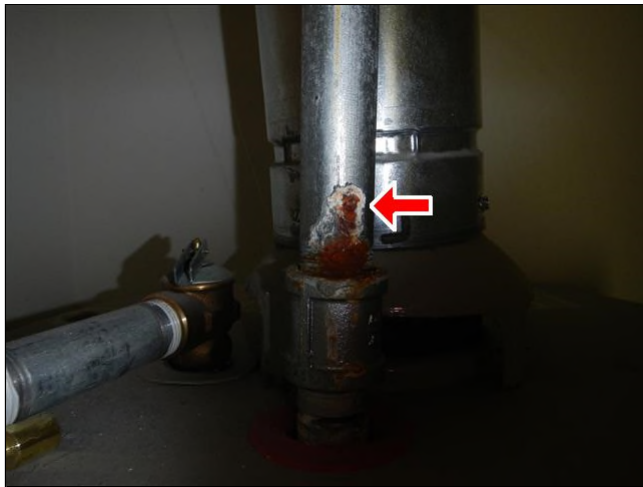
Item 1(Picture) Small pin hole leak needs repair.

Small pin hole leak needs repair.

Evaluation and repair by a licensed plumbing contractor is recommended.

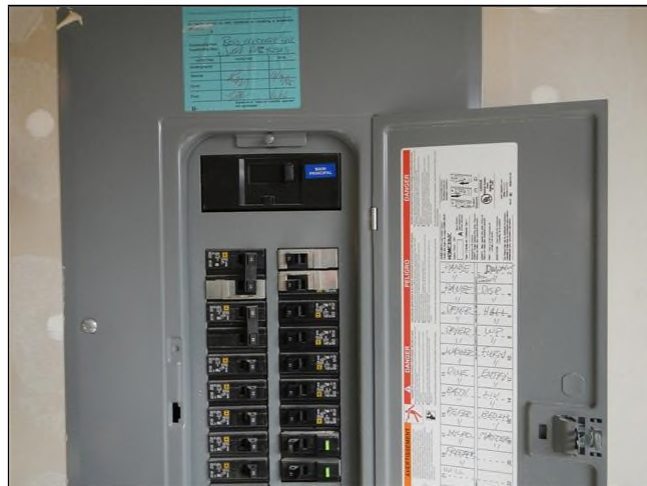
Item 1(Picture) Properly labeled 200 amp Main Panel

Properly labeled 200 amp Main Panel

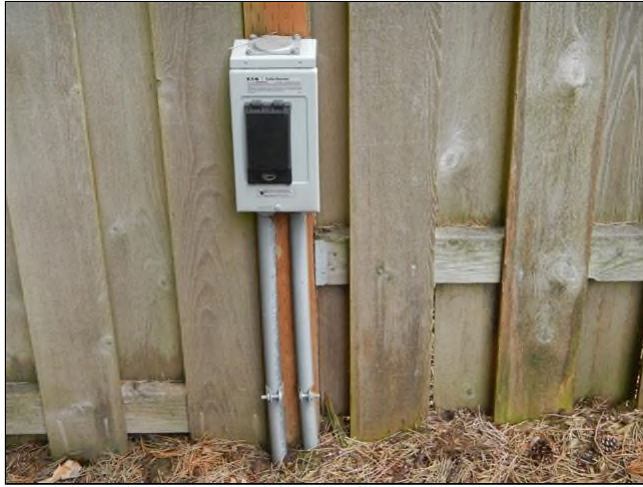
Item 2(Picture)

Oudoor 50 amp breaker for Hot tub.

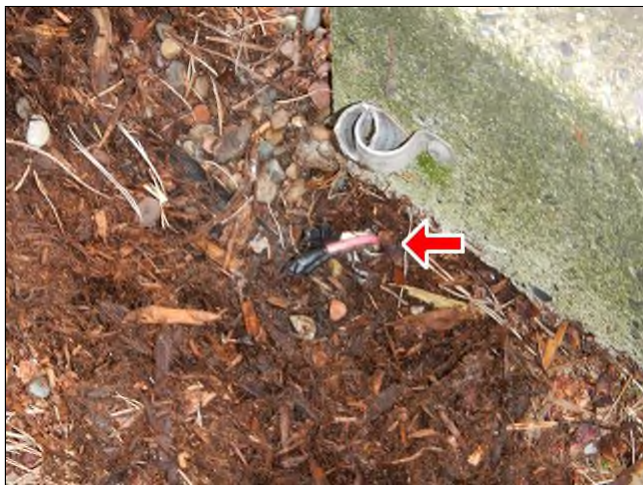
Dead wires coming out of ground in backyard for previous hot tub.

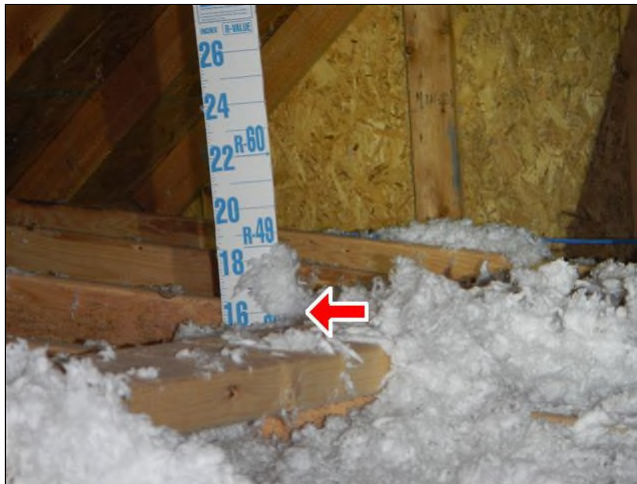
Item 1(Picture) Good insulation in attic. Recommended 14in minimum. Attic has 16in.

Good insulation in attic

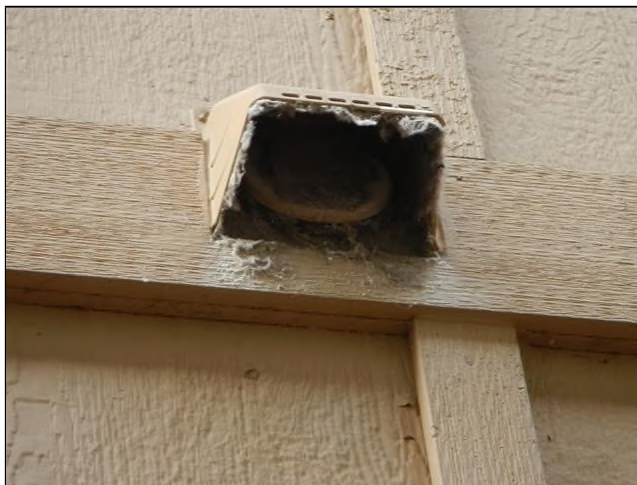
Item 1(Picture) The dryer vent needs to be cleaned of lint. As a result, the flap is not closing properly and is a potential pest entrance to the home. Repair is recommended.

The dryer vent needs to be cleaned of lint. As a result, the flap is not closing properly and is a potential pest entrance to the home. Repair is recommended.
